Presqu'ile

Heritage Building Stewardship Plan

Prepared by Geoff Hodgins Architect with BRAY Heritage in 2005

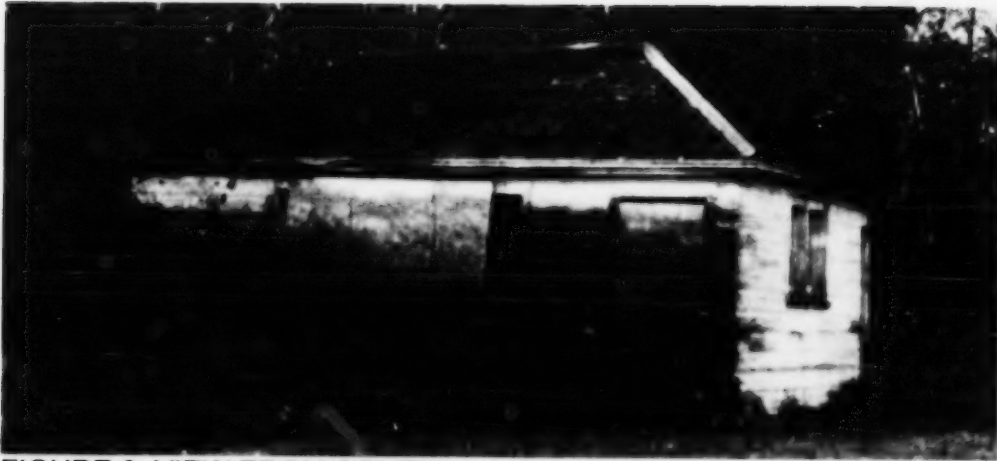
FIGURE 8: VIEW FROM SOUTH

This is a 12'- 4" x 24'- 4" frame shed with 7" face, horizontal wood siding on the exterior and 4" cedar T&G on the interior; walls and ceiling are all original. The lower 8"- 12" of the walls are severely rotted but the remaining structure is in surprisingly good condition. The floor, however, is in very poor shape. The roof is covered with the original cedar shakes with metal ridge caps. The roof is very weathered but apparently does not leak. The original metal gutters are in place but are in very poor condition. The original door has been replaced with a poorly fitted utility door. Some windows are missing and boarded up. Some of the original windows (casement and fixed) remain in place. The building is tilting.

- raise the building, set it on a pier foundation with a new floor system and rebuild lower section of walls
- repair/replace windows to match originals
- replace door with period door
- carefully monitor roof condition
- replace gutters to match original
- paint exterior.

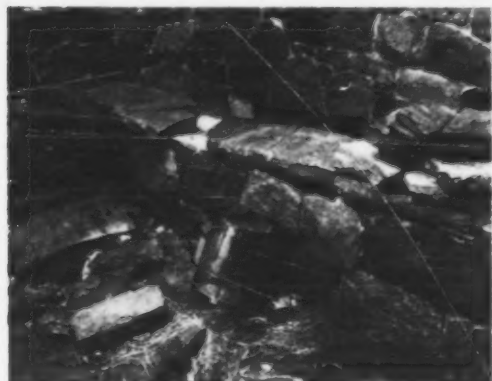
figure 32 - Retaining Wall

The stone and pointing is in good shape with the exception of the retaining wall by the basement stairwell (*see figure 32*).

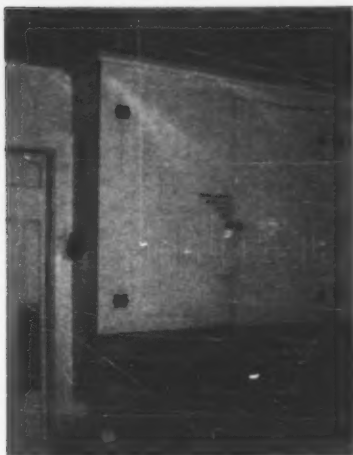
figure 40 - Original Millwork

The original kitchen cabinets are in place (*see figure 40*).
